## The Restoration of the Historic Oriels at Beiteddine Palace

*A Journey Through Time and Craftsmanship*

*Stages, methodologies, discoveries, challenges, and solutions*

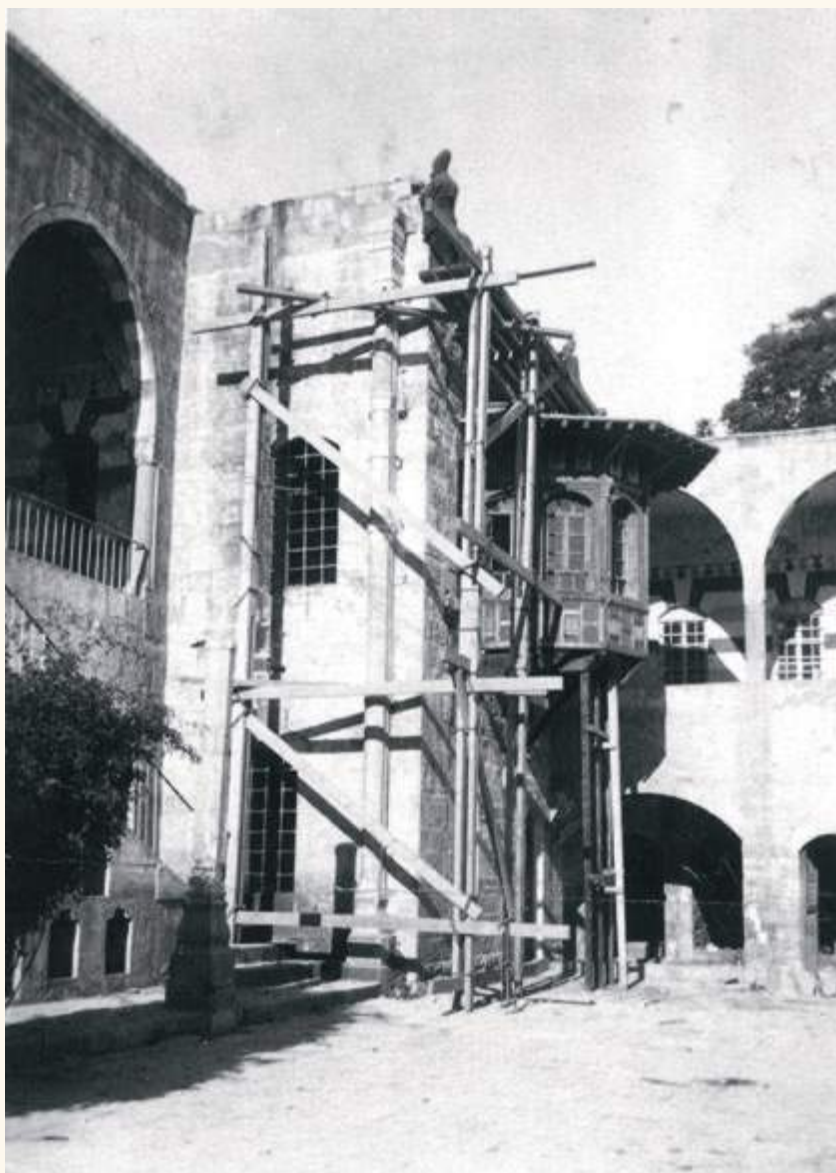
Fig. 8 Archival image capturing restoration work on the lower section of the Dār al-Ḥarīm Oriel, with scaffolding in place

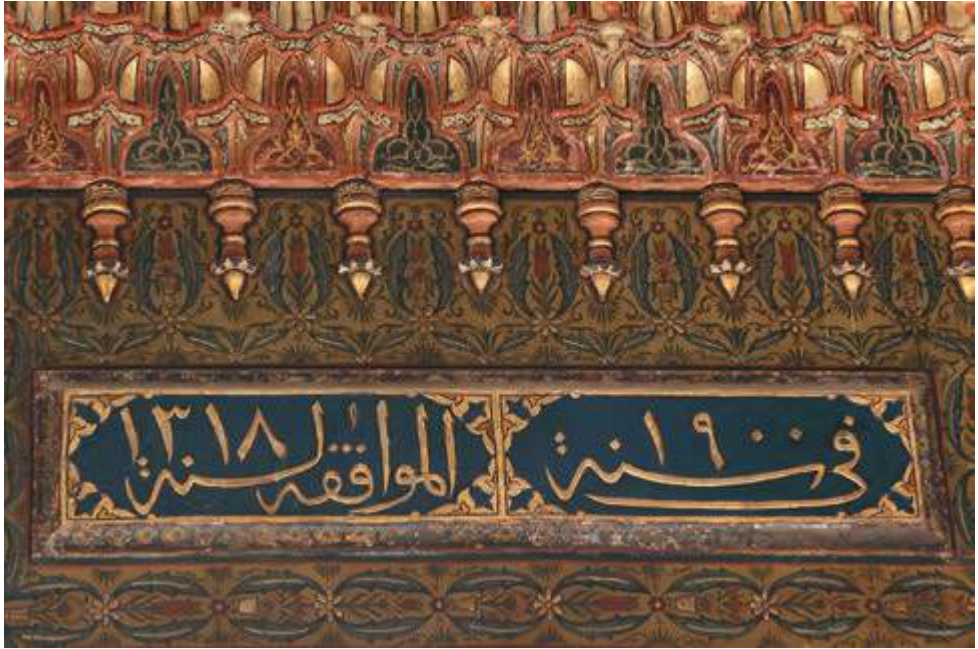
Fig. 19 Inscription commemorating the 1900 renovation of the Salamlek by the Ottoman Mutasarrıfs, 2025

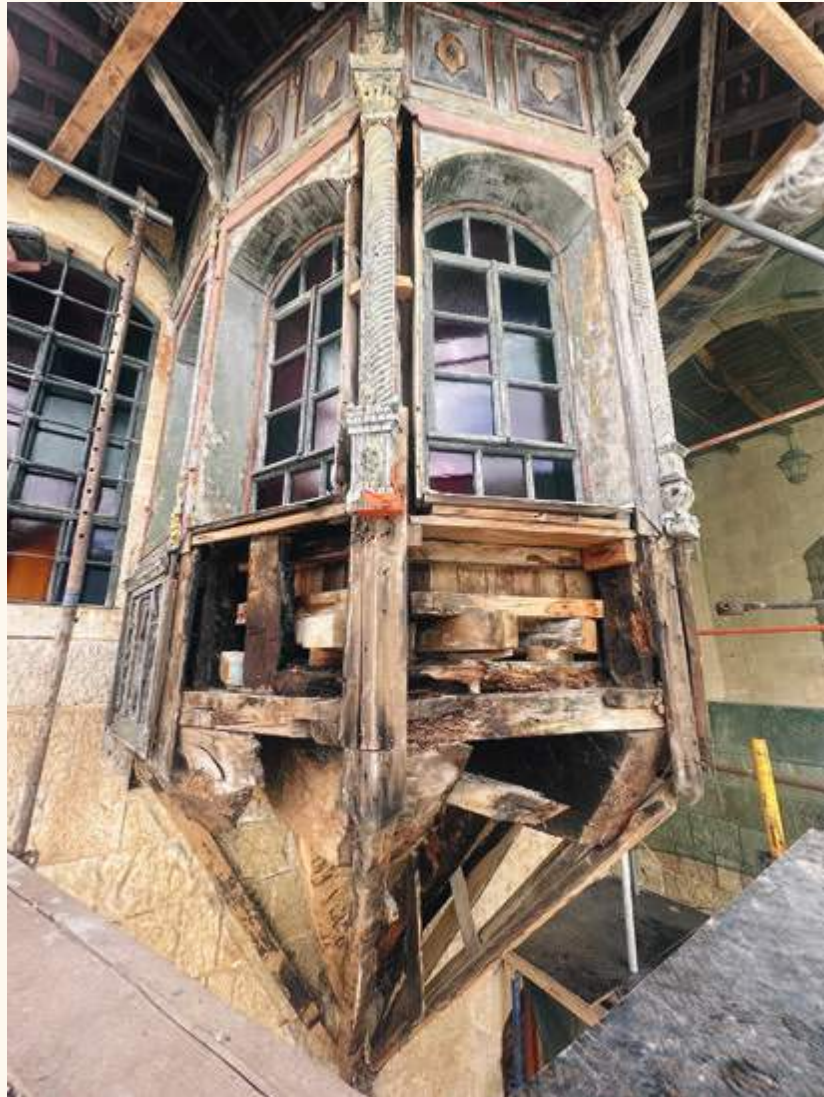
*Fig. 7 Removal of the wooden panels at the lower section of the Dār al-Harim Oriel to reveal its structure*

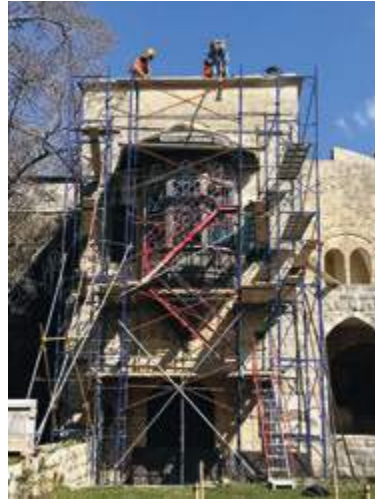
Fig. 15

The restoration of the Salamlek Oriel followed a similar sequence to that of the Dār al-Ḥarīm, with some variations. The process began with the installation of scaffolding and the propping of the structure (Fig. 15). The triangular wooden panels at the base of the oriel were documented and dismantled to assess the structural condition further.

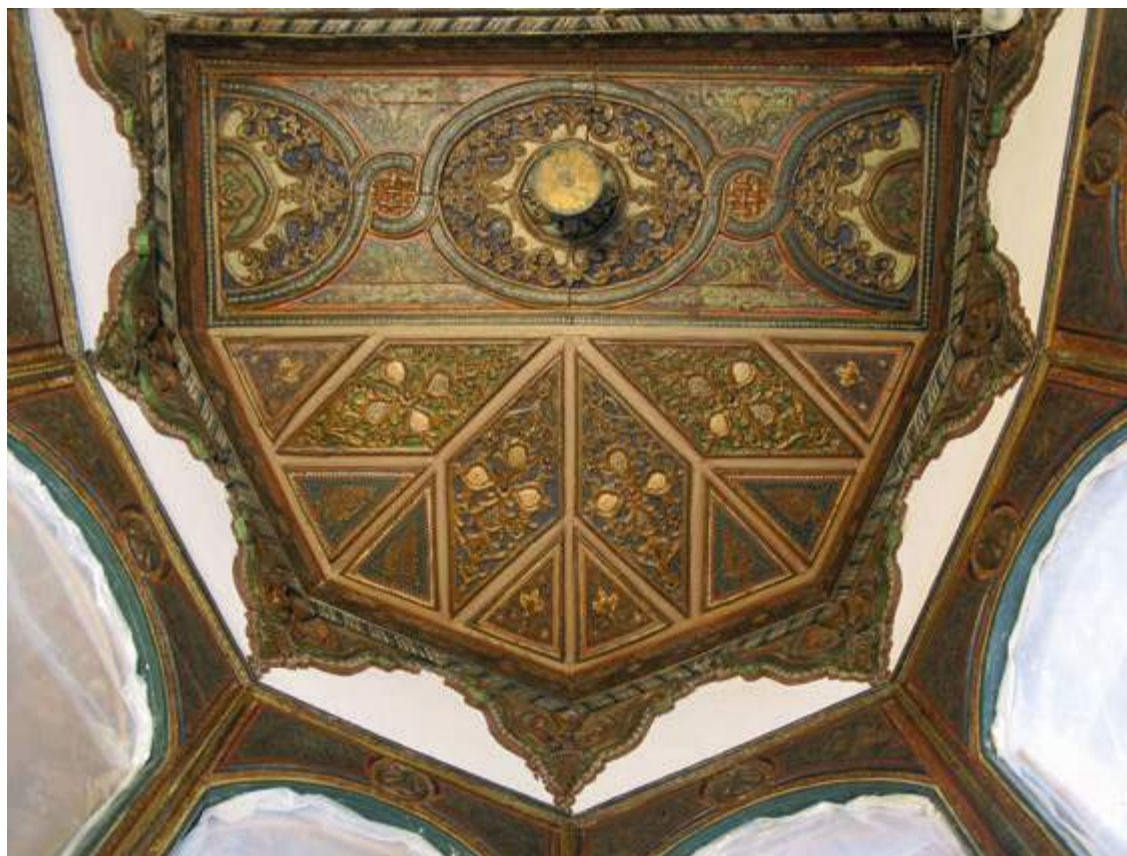
Fig. 10 Dār al-Harīm oriel prior to conservation. 2024

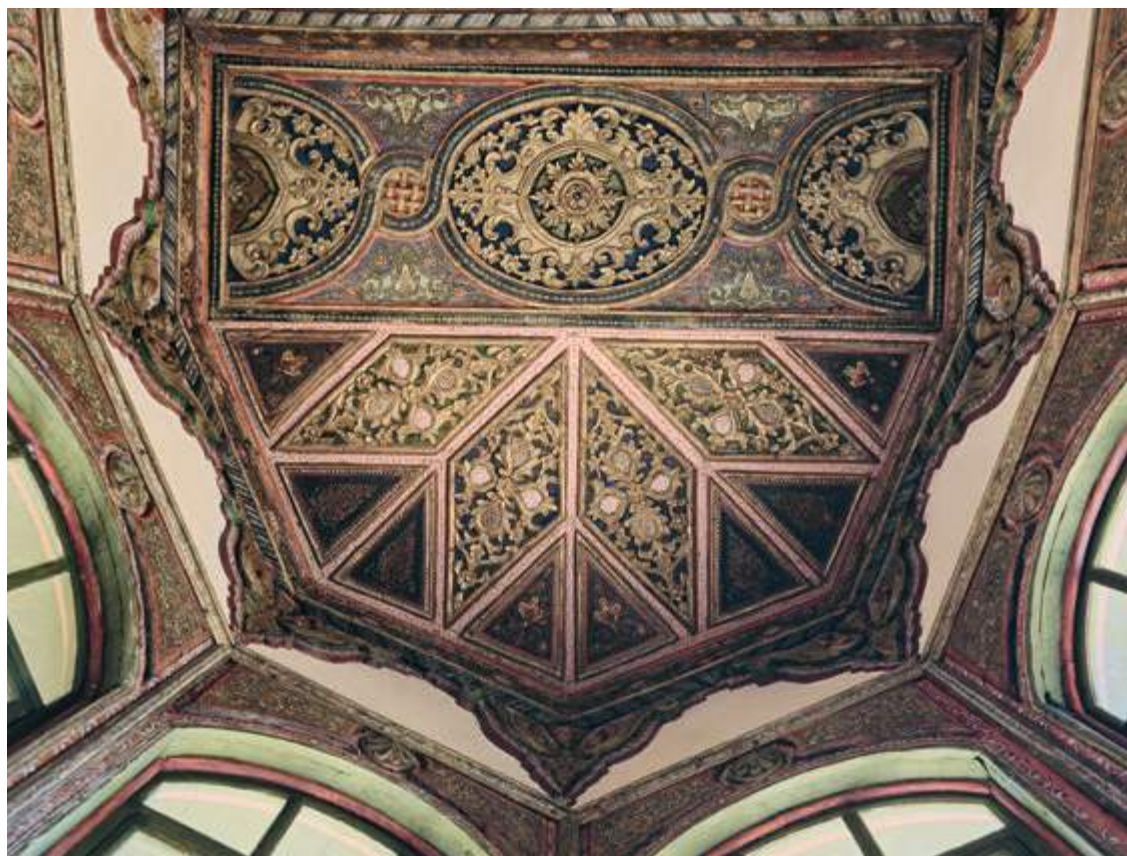
Fig. 11 Dār al-Ḥarīm oriel after conservation, 2024

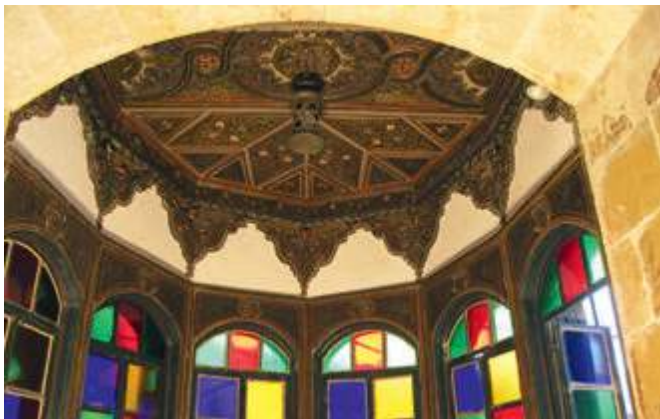
Fig. 12 Dār al-Ḥarīm oriel. Ceiling and modern coloured windows, prior to conservation. 2024

The wood carvings seem to have been crafted by different workshops or carvers across various periods, all predating the mid-19th century, as the metal leaf technique used in these pieces fell out of practice after the 1850s. Variations in the application of the copper alloy leaf have resulted in differing states of preservation. Three distinct types of metal leaf degradation are visible: two in the ceiling and a third in the serwāls. The severely damaged ceiling carvings have been painted over with a bronze color.

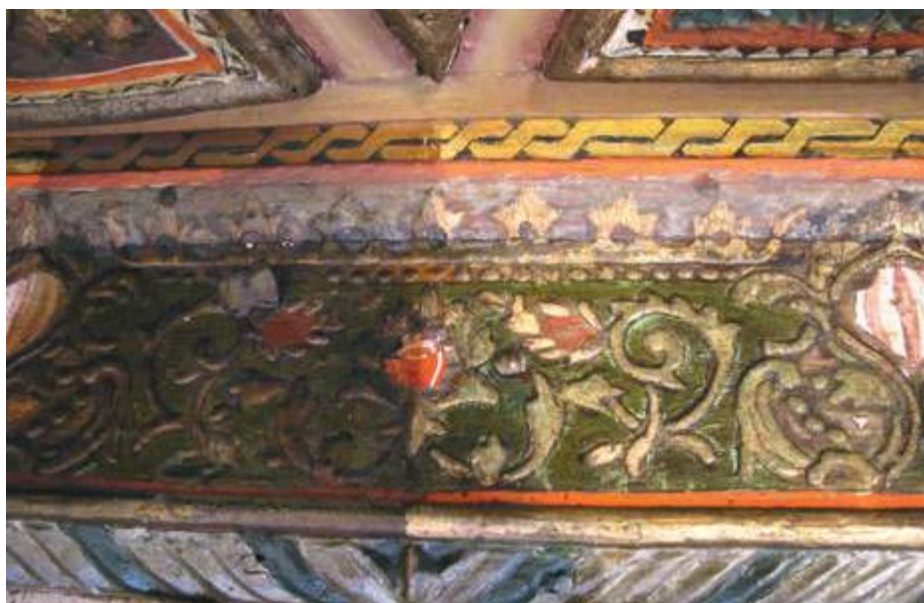
Fig. 16

*Figs. 15–16 Dār al-Ḥarīm oriel.  
Details of panels during the  
removal of later darkened  
varnish layers. 2024*

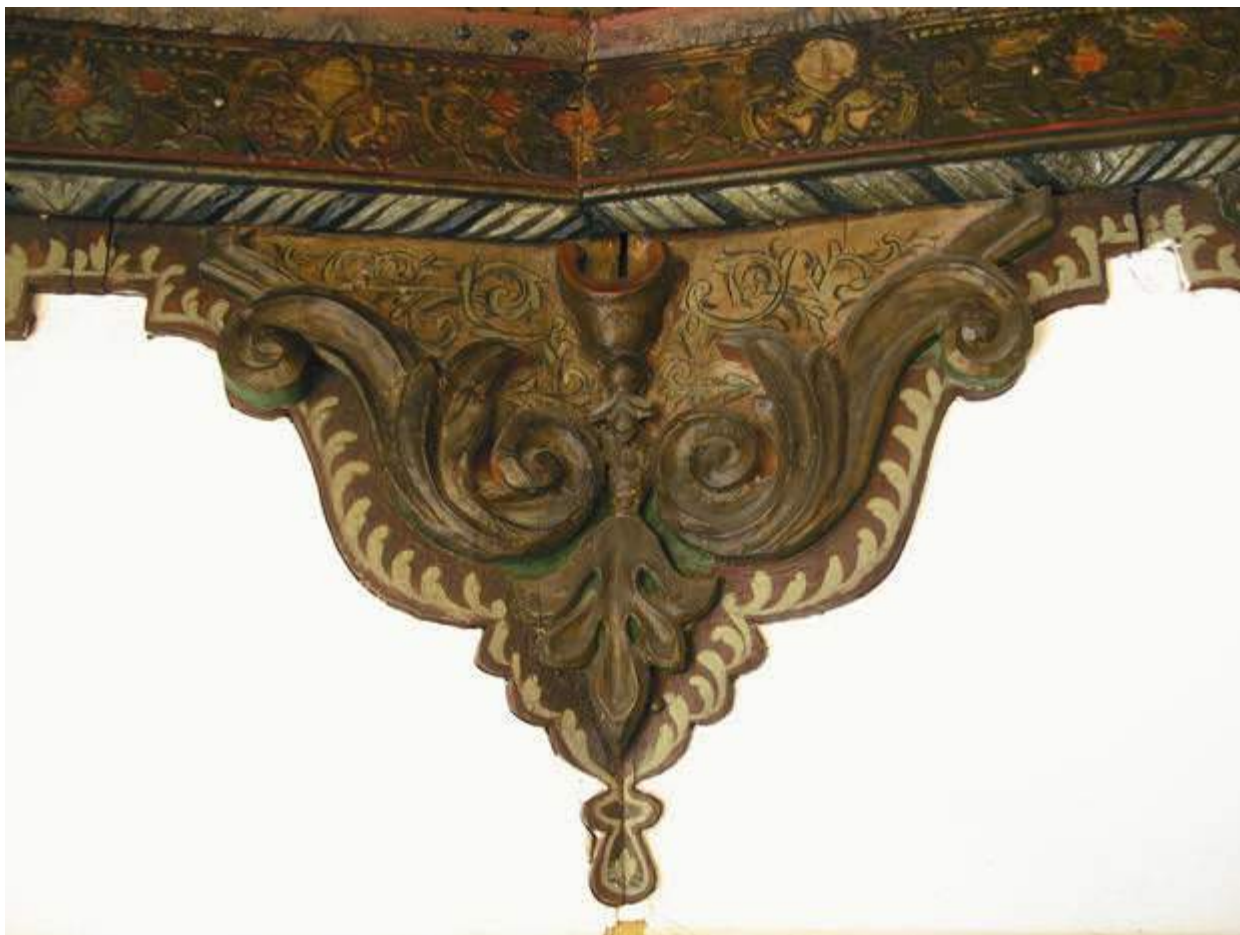
Fig. 17 Dār al-Ḥarīm oriel. Detail of a serwāl prior to conservation, 2024

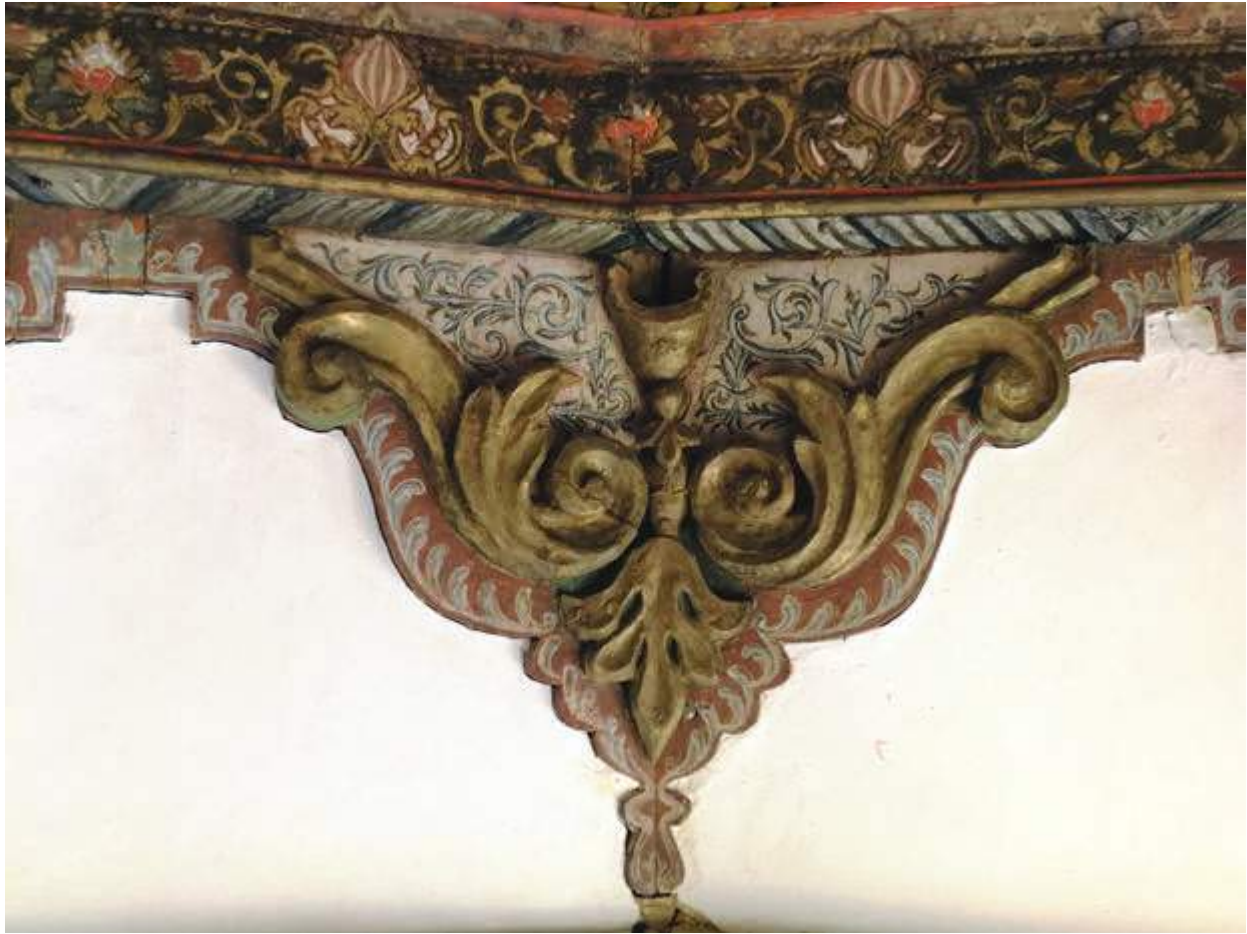
Fig. 18. Dār al-Ḥarīm oriel. Detail of a serwāl after conservation and restoration. 2024

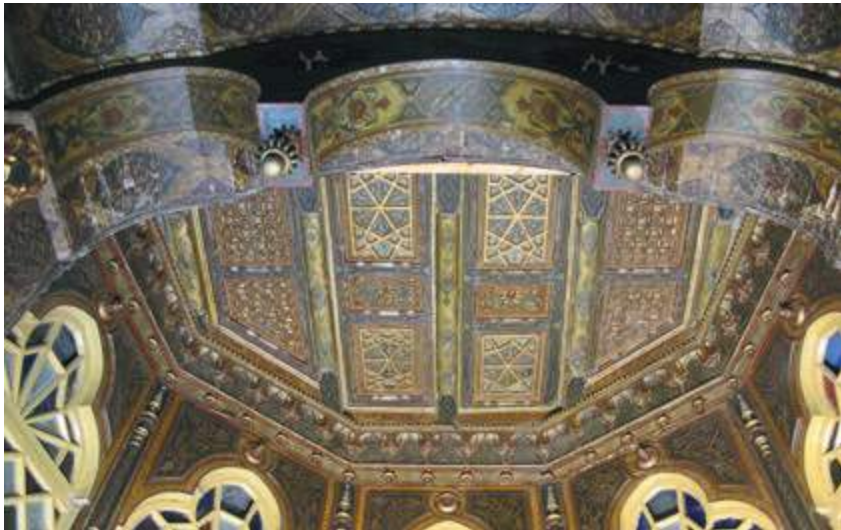
The surface decoration of the wooden elements has been heavily damaged by water leaks, as evidenced by the significant flaking of Ḥajamī paste in the relief ornaments and peeling paint layers.

Fig. 19 Salamlek oriel. Ceiling prior to conservation. 2024

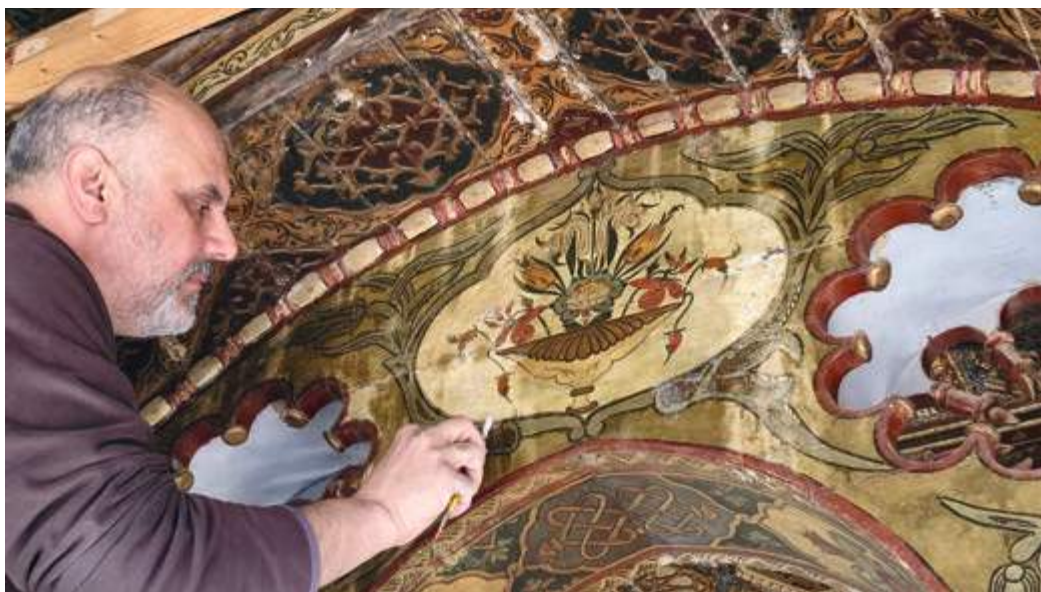
Fig. 26 Salamlek oriel. The conservator working on the conservation of the arch. 2024

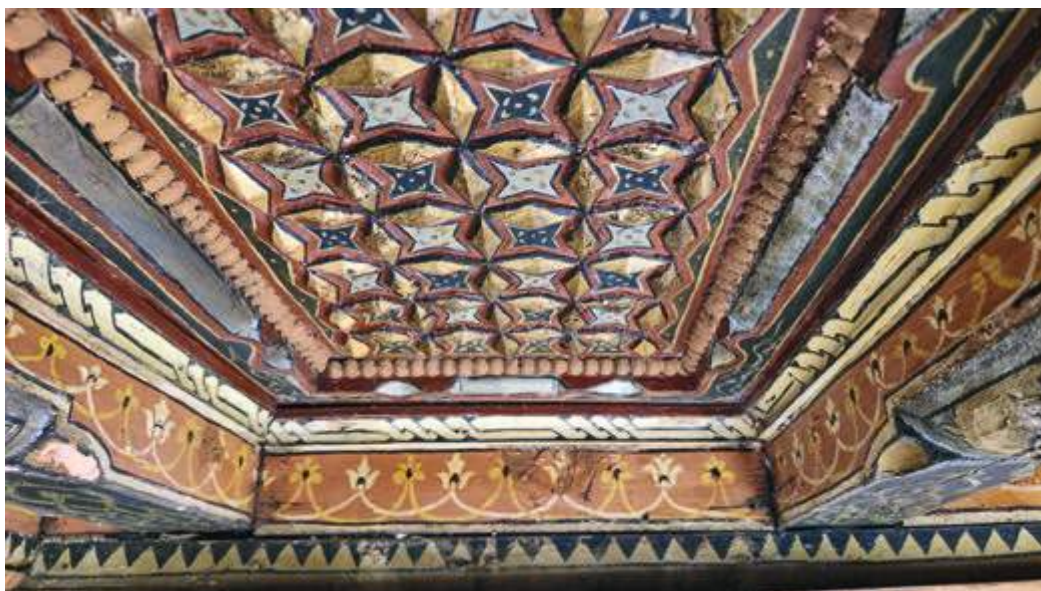
Fig. 27 Salamlek Oriel. Detail of the ceiling. 2024
